2018 - 2019 Road Paving Improvements

City of Rio Communities, New Mexico

Prepared by: Rio Communities' Planning and Zonning Commission

RE: 2018-2019 Cooperative Agreement Program Project Proposal

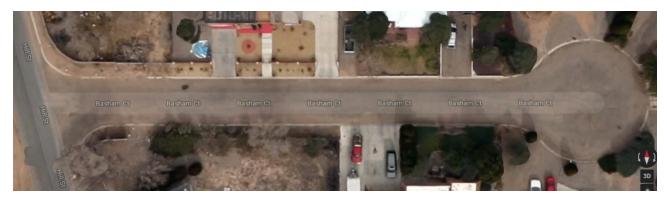
Repair #1 Basham Ct east of Hill St

Condition: Fair

Assessment: Moderate to severe raveling with loss of fine and coarse

aggregate. Some longitudinal and transverse cracks with evidence of block cracking up to 50% of surface and

potholes interspersed throughout.

Repair: Repair potholes and apply 3/8" chip and seal with fog coat

overlay over entire length and width of surface.

Scope of Work: Potholes and surface faults should be squared and dug to a

minimum depth of 3" before filling with premixed

bituminous material to correct potholes and patches.

Apply liquid asphalt and aggregate (3/8") on full width

sections of paved roadways to seal the surface.

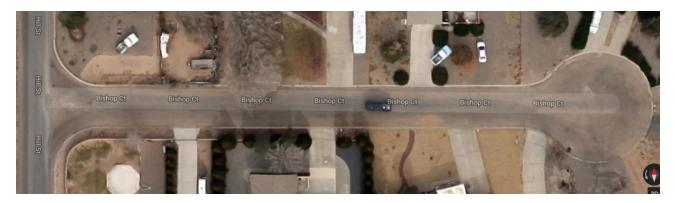
Repair #2 Bishop Ct east of Hill St

Condition: Fair

Assessment: Moderate to severe raveling with loss of fine and coarse

aggregate. Some longitudinal and transverse cracks with evidence of block cracking up to 50% of surface and

potholes interspersed throughout.

Repair: Repair potholes and apply 3/8" chip and seal with fog coat

overlay over entire length and width of surface.

Scope of Work: Potholes and surface faults should be squared and dug to a

minimum depth of 3" before filling with premixed

bituminous material to correct potholes and patches.

Apply liquid asphalt and aggregate (3/8") on full width

sections of paved roadways to seal the surface.

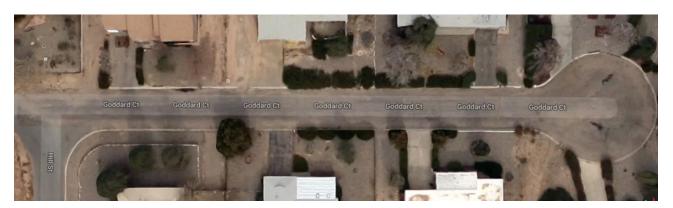
Repair #3 Goddard Ct east of Hill St

Condition: Poor

Assessment: Complete breakdown of asphalt and base course

Repair: Full service repair (cut and replace)

Scope of Work: Mark and saw-cut area of repair; jackhammer and remove

defective material; remove, replace with compacted base course; apply tack coat; place hot asphalt patch material in two 1.5-inch lifts, compacting after each applied lift; seal

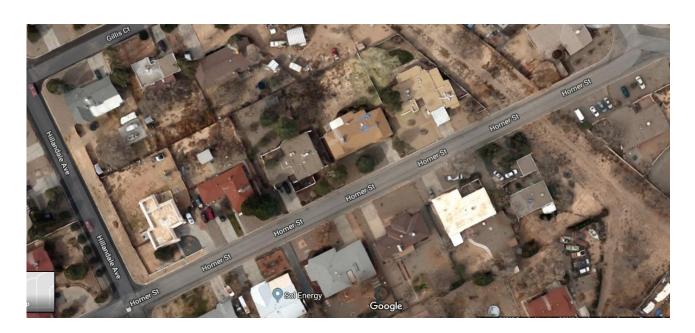
Repair #4 Horner St, north of Hillandale Ave to intersection of Grey Pl & Gorman

Condition: Fair

Assessment: Moderate to severe raveling with loss of fine and coarse

aggregate. Some longitudinal and transverse cracks with evidence of block cracking up to 50% of surface and

potholes interspersed throughout.

Repair: Repair potholes and apply 3/8" chip and seal with fog coat

overlay over entire length and width of surface.

Scope of Work: Potholes and surface faults should be squared and dug to a

minimum depth of 3" before filling with premixed

bituminous material to correct potholes and patches.

Apply liquid asphalt and aggregate (3/8") on full width

sections of paved roadways to seal the surface.

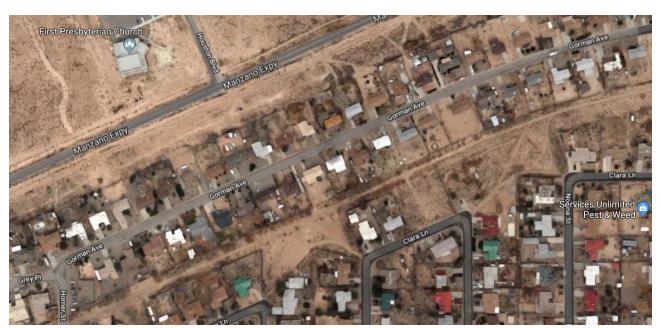
Repair #5 Gorman Ave northeast of Horner and Grey, ending at Pageant St

Condition: Fair to poor

Assessment: Moderate to severe raveling with loss of fine and coarse

aggregate. Some longitudinal and transverse cracks with evidence of block cracking up to 50% of surface and sever surface breakdown interspersed along approximately 30%

of centerline of road.

Repair: Combination cut and replace asphalt areas especially along

centerline of road, and chip and fog seal entire length and

width of road.

Scope of Work: Cut and replace areas along centerline: Mark and saw-cut

area of repair; jackhammer and remove defective material; remove, replace with compacted base course; apply tack coat; place hot asphalt patch material in two 1.5-inch lifts,

compacting after each applied lift; seal with joint sealant material.

Chip/fog seal length of road: Apply liquid asphalt and aggregate (3/8") on full width sections of paved roadways to seal the surface.

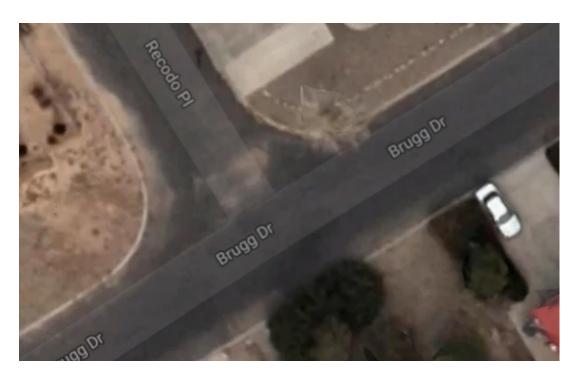
Repair #6
Brugg Dr and Recodo PI (full intersection)

Condition: Poor

Assessment: Complete breakdown of asphalt and base course

Repair: Cut and replace

Scope of Work: Mark and saw-cut area of repair; jackhammer and remove

defective material; remove, replace with compacted base course; apply tack coat; place hot asphalt patch material in two 1.5-inch lifts, compacting after each applied lift; seal

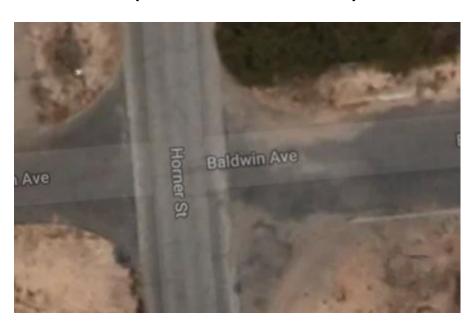
Repair #7 Horner and Baldwin (east side of intersection)

Condition: Poor

Assessment: Complete breakdown of asphalt and base course

Repair: Cut and replace

Scope of Work: Mark and saw-cut area of repair; jackhammer and remove

defective material; remove, replace with compacted base course; apply tack coat; place hot asphalt patch material in two 1.5-inch lifts, compacting after each applied lift; seal

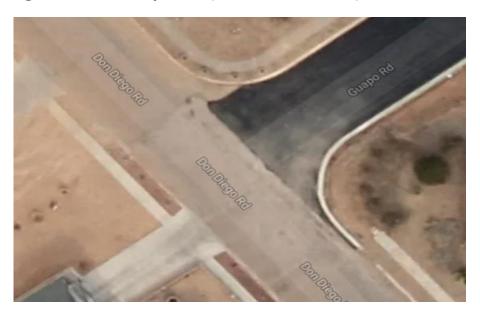
Repair #8 Don Diego Rd and Guapo Rd (full intersection)

Condition: Poor

Assessment: Complete breakdown of asphalt and base course

Repair: Cut and replace

Scope of Work: Mark and saw-cut area of repair; jackhammer and remove

defective material; remove, replace with compacted base course; apply tack coat; place hot asphalt patch material in two 1.5-inch lifts, compacting after each applied lift; seal

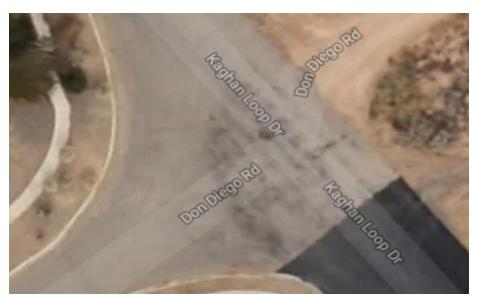
Repair #9 Don Diego Rd and Kaghan Lp (center of intersection)

Condition: Poor

Assessment: Complete breakdown of asphalt and base course

Repair: Cut and replace

Scope of Work: Mark and saw-cut area of repair; jackhammer and remove

defective material; remove, replace with compacted base course; apply tack coat; place hot asphalt patch material in two 1.5-inch lifts, compacting after each applied lift; seal

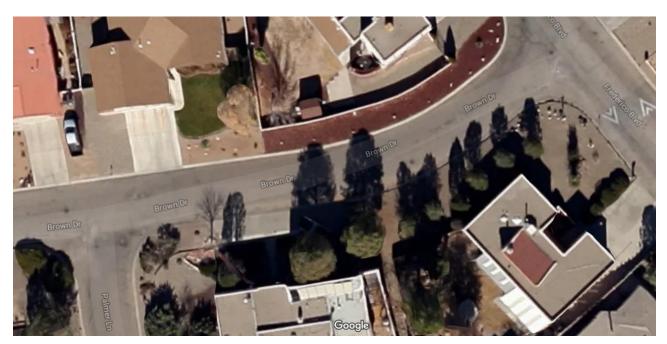
Repair #10 Brown Dr (west of Frederico to Palmer)

Condition: Poor

Assessment: Complete breakdown of asphalt and base course

Repair: Full service repair and replace

Scope of Work: Mark and saw-cut area of repair; jackhammer and remove

defective material; remove, replace with compacted base course; apply tack coat; place hot asphalt patch material in two 1.5-inch lifts, compacting after each applied lift; seal
