2019 – 2020 Road Paving Improvements

**City of Rio Communities,
New Mexico**

Prepared by: Rio Communities'
Planning and Zoning Commission

Summary of 2019-2020 Road Paving Improvements

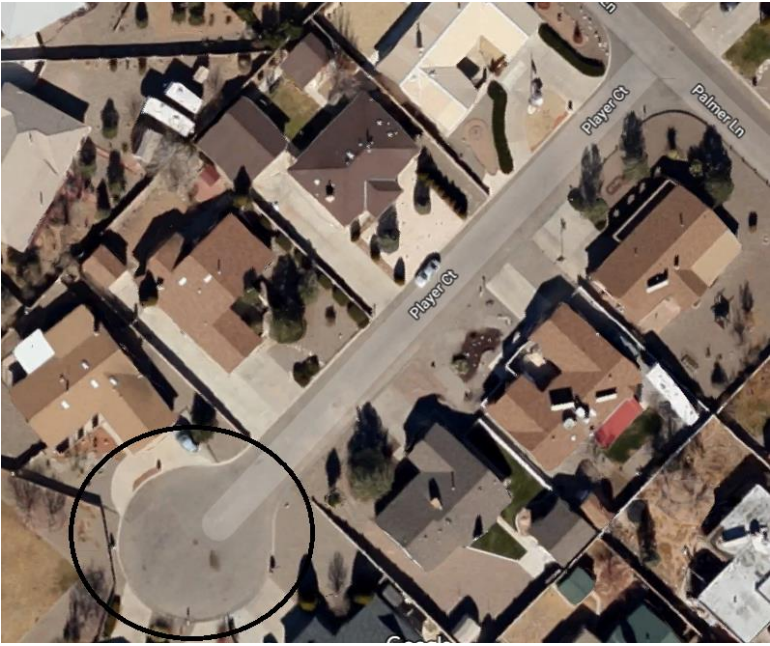
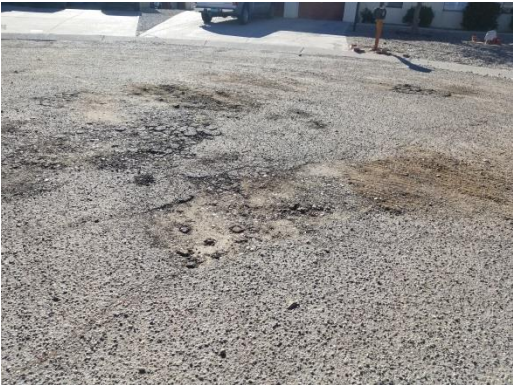
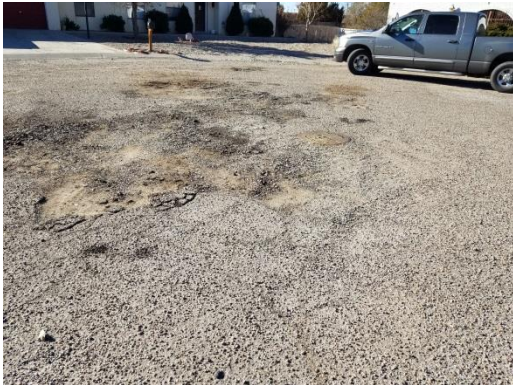
Repair #1

Surface Condition: Poor

Assessment: Complete breakdown of asphalt and base course

Repair: Full service repair (cut and replace)
Area: 5,783 SF (L27' X W28' X R40')

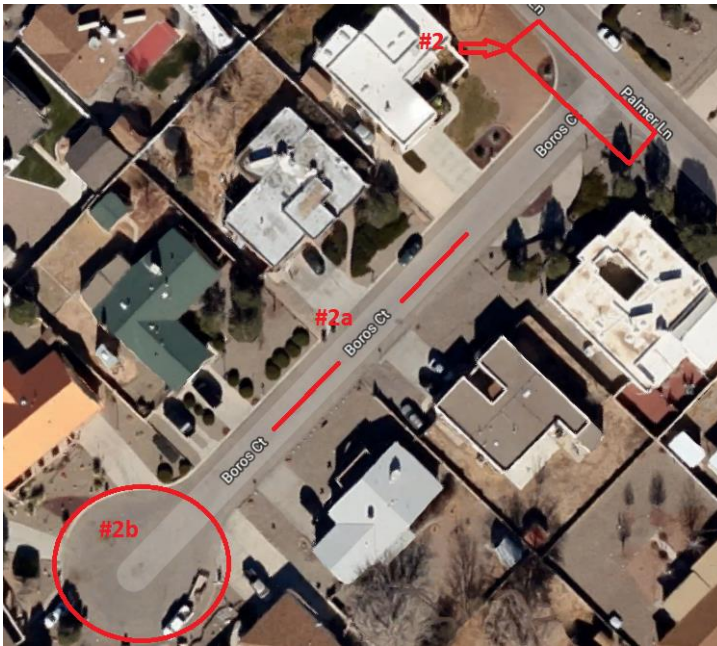
Repair #2
Intersection of Boros Ct & Palmer Ln

Surface Condition: Poor
Assessment: Complete breakdown of asphalt and base course
Repair: Full service repair (cut and replace)
Area: 2,400 SF (L40' X W60')

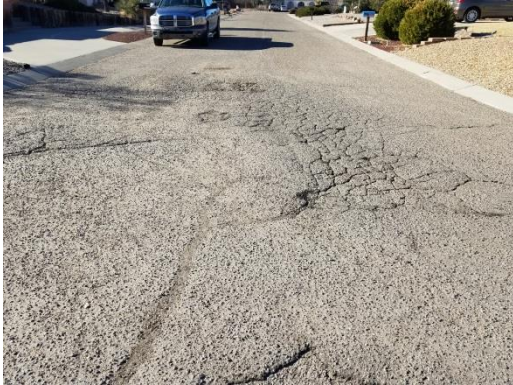
Repair #2a
Centerline Sean of Boros Ct

Surface Condition: Poor

Assessment: Complete breakdown of asphalt and base course

Repair: Full service repair (cut and replace)

Area: 306 SF (103' X 3')

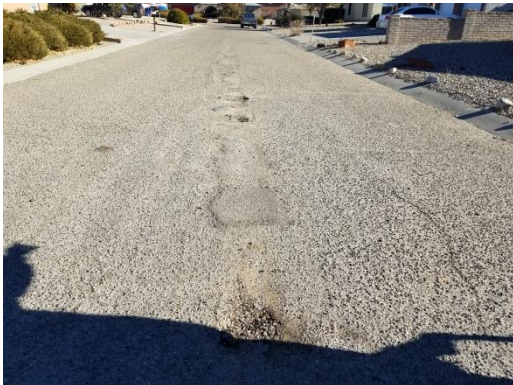
Repair 2b

Surface Condition: Poor

Assessment: Complete breakdown of asphalt and base course

Repair: Full service repair (cut and replace)

Area: 5027 SF (40' radius of Cul de sac)

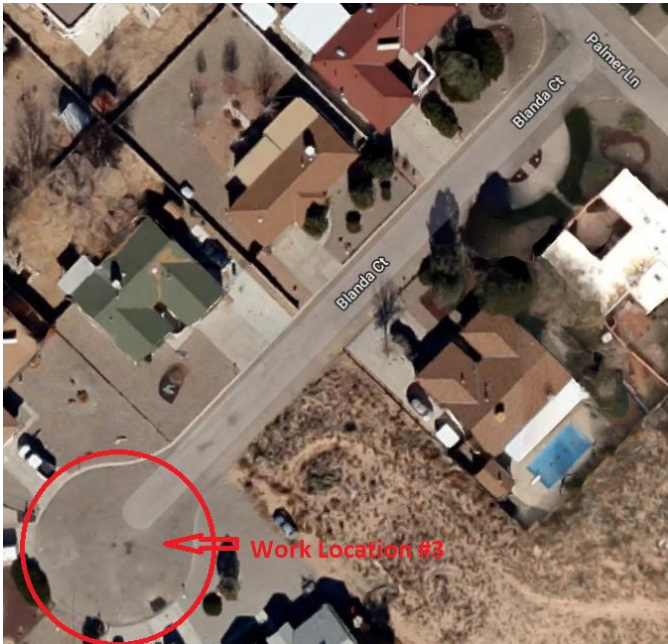
Repair 3
Blanda Ct (End of Cul de sac)

Surface Condition: Poor

Assessment: Complete breakdown of asphalt and base course

Repair: Full service repair (cut and replace)

Area: 6,707 SF (L60' X W28' X R40')

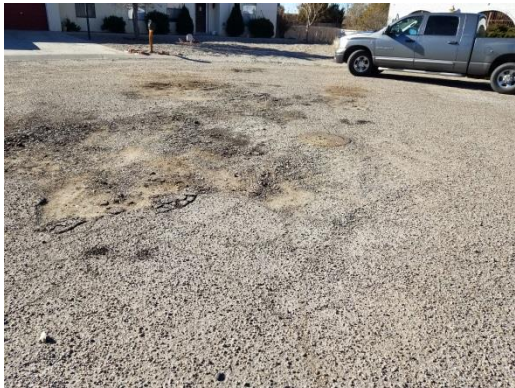
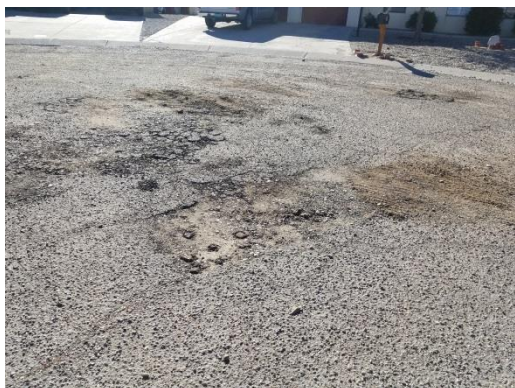
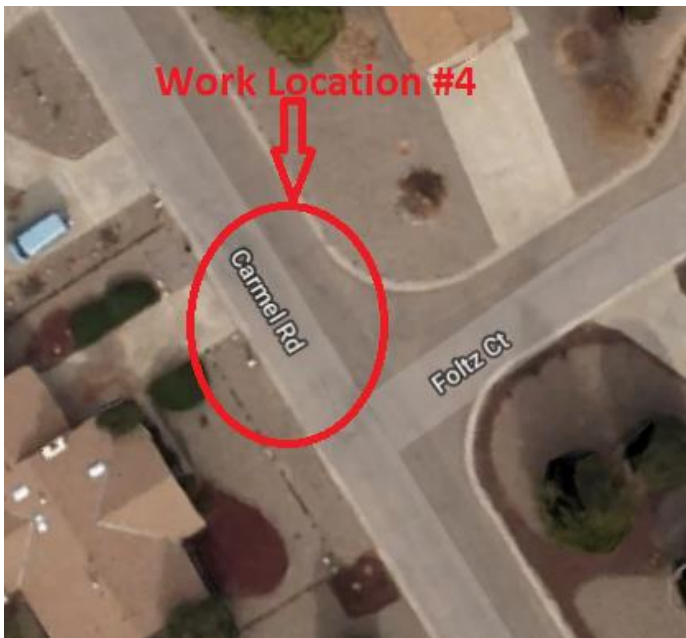
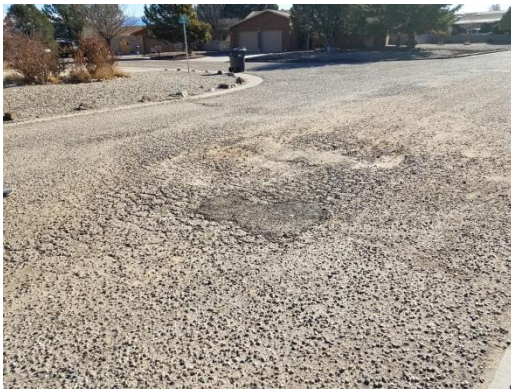
Repair #4
Carmel Rd (section just prior to intersection of Foltz Ct)

Surface Condition: Poor

Assessment: Complete breakdown of asphalt and base course

Repair: Full service repair (cut and replace)

Area: 3,096 SF (L86' X W36')

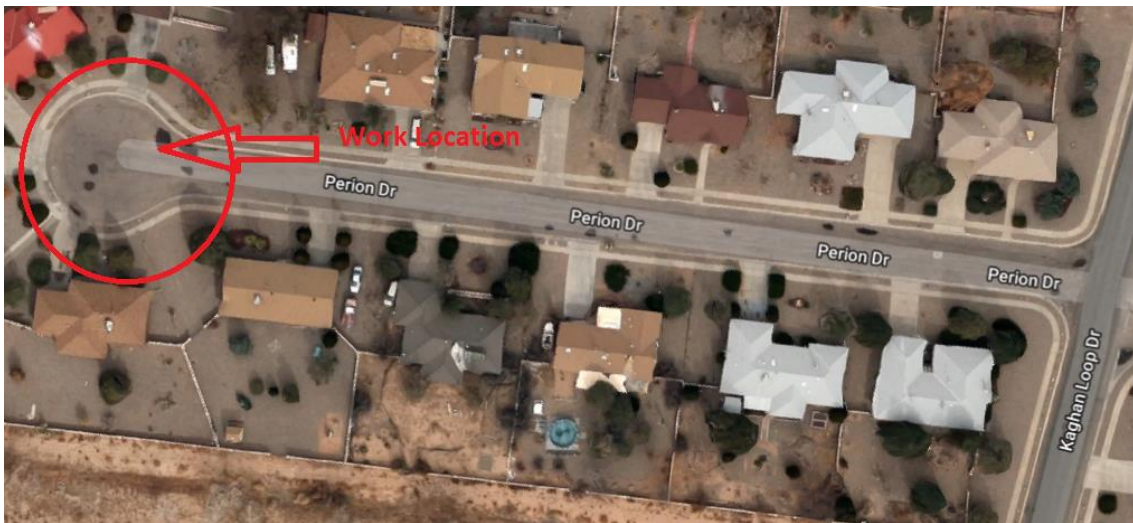
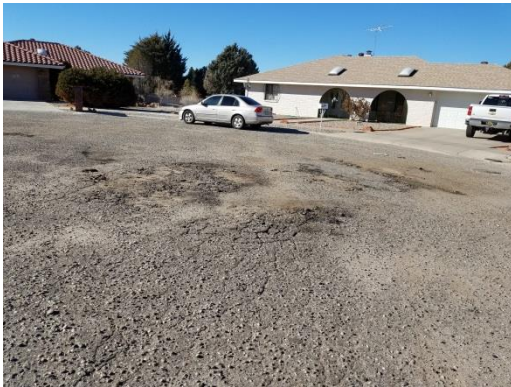
Repair 5

Surface Condition: Poor

Assessment: Complete breakdown of asphalt and base course

Repair: Full service repair (cut and replace)

Area: 5,027 SF (R 40')

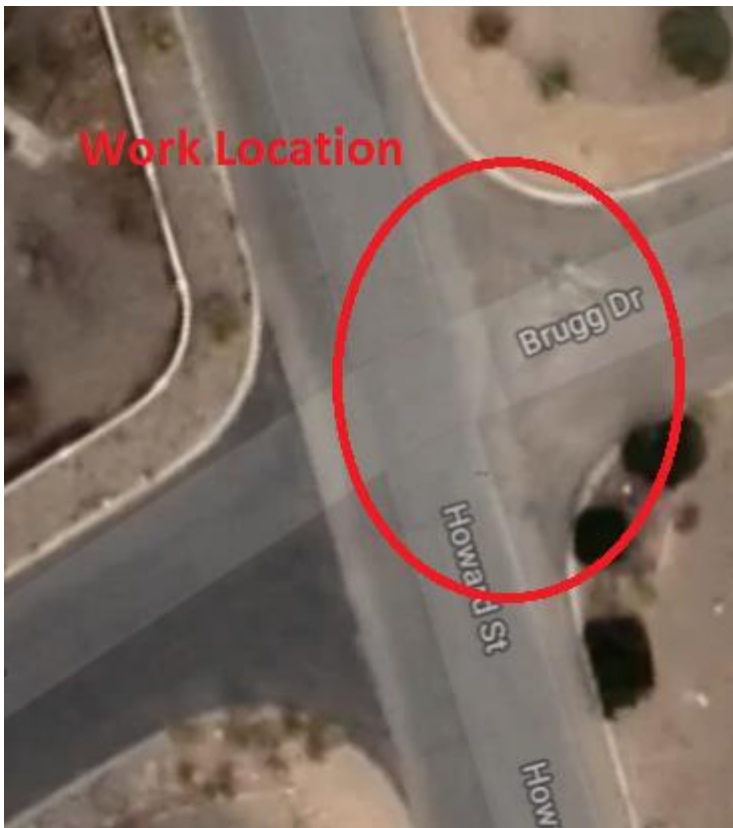
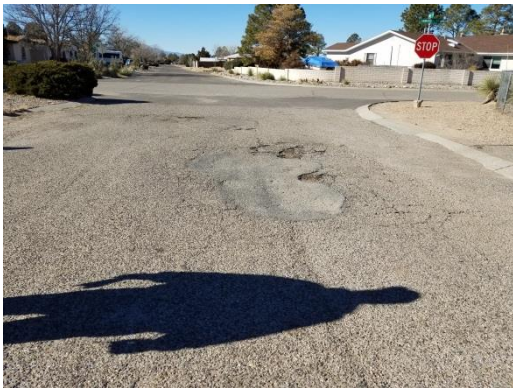
Repair #6

Surface Condition: Poor

Assessment: Complete breakdown of asphalt and base course

Repair: Full service repair (cut and replace)

Area: 1,316 SF (L47' X W28')

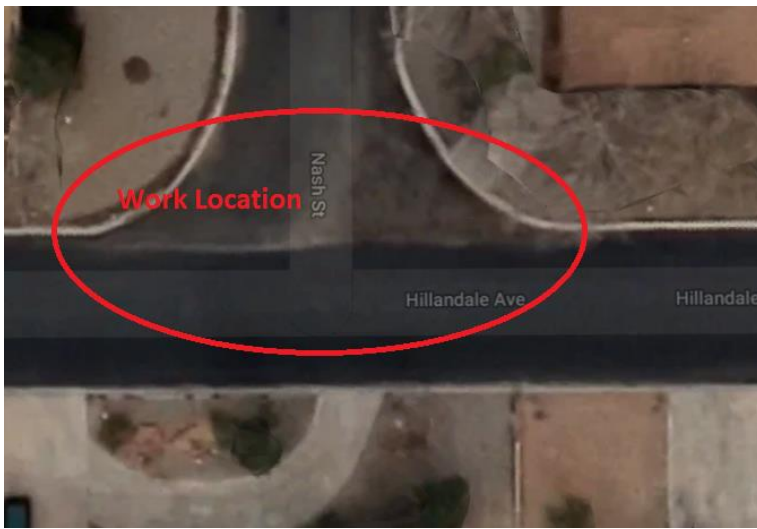
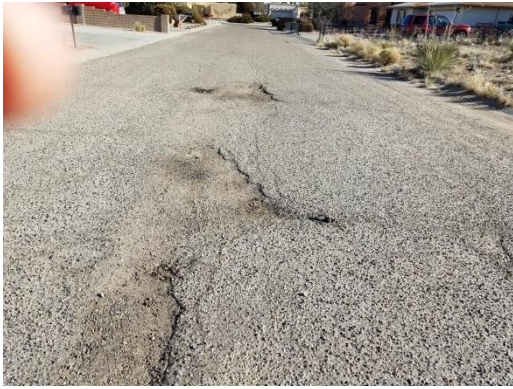
Repair #7

Surface Condition: Poor

Assessment: Complete breakdown of asphalt and base course

Repair: Full service repair (cut and replace)

Area: 1,330 SF (L38' X W35')

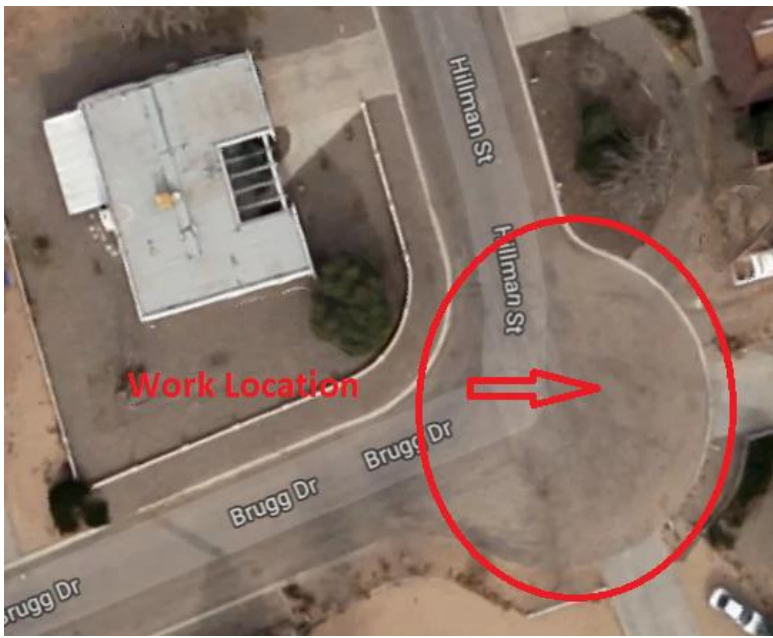
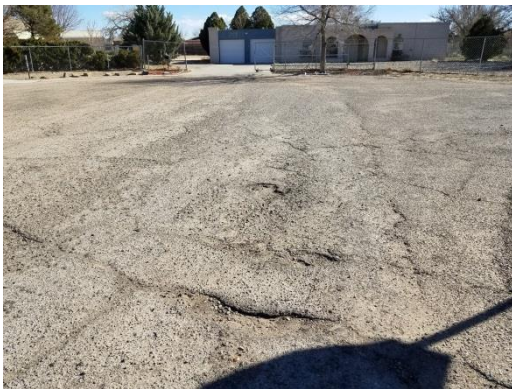
Repair #8

Surface Condition: Poor

Assessment: Complete breakdown of asphalt and base course

Repair: Full service repair (cut and replace)

Area: 5,027 SF (R40')

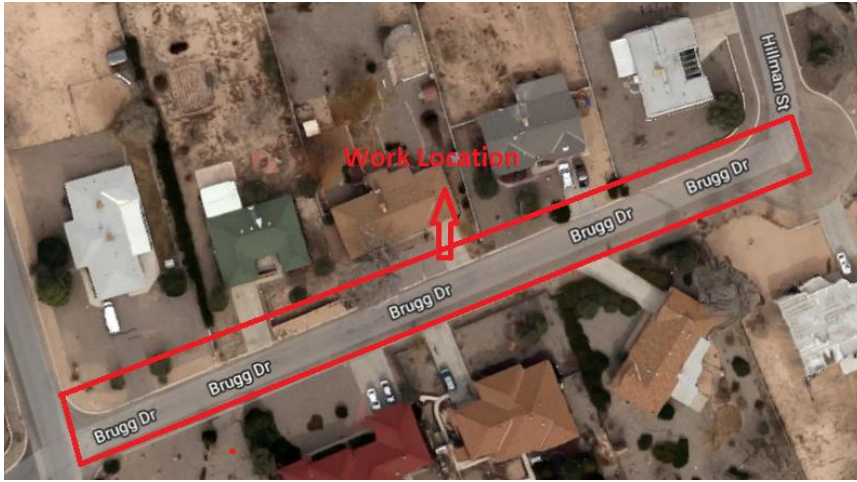
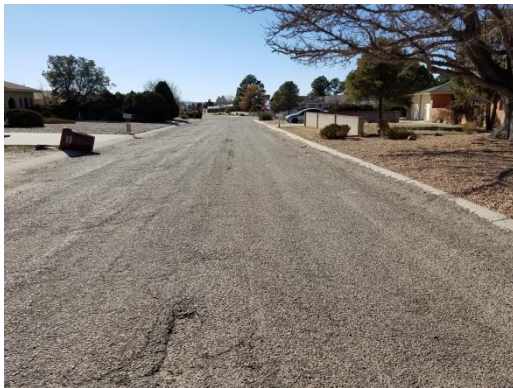
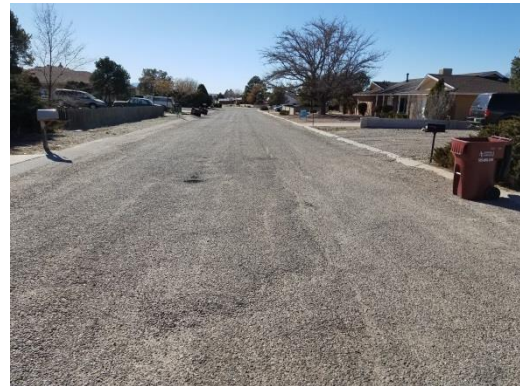
Repair #9

Surface Condition: Poor

Assessment: Complete breakdown of asphalt and base course

Repair: Repair pothole/chip and seal

Area: 11,200 SF (L400' X 28')

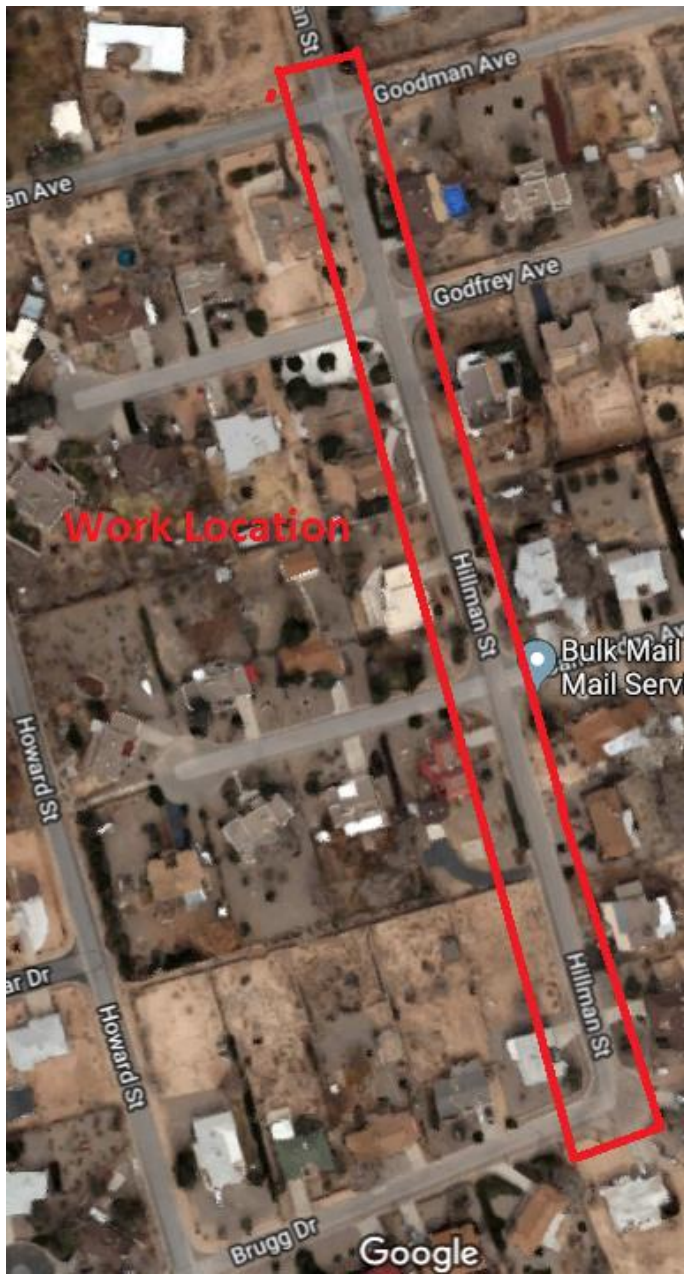
Repair #9a

Surface Condition: Poor

Assessment: Complete breakdown of asphalt and base course

Repair: Repair pot hole/ chip and seal

Area: 25,956 SF (L927' X 28')

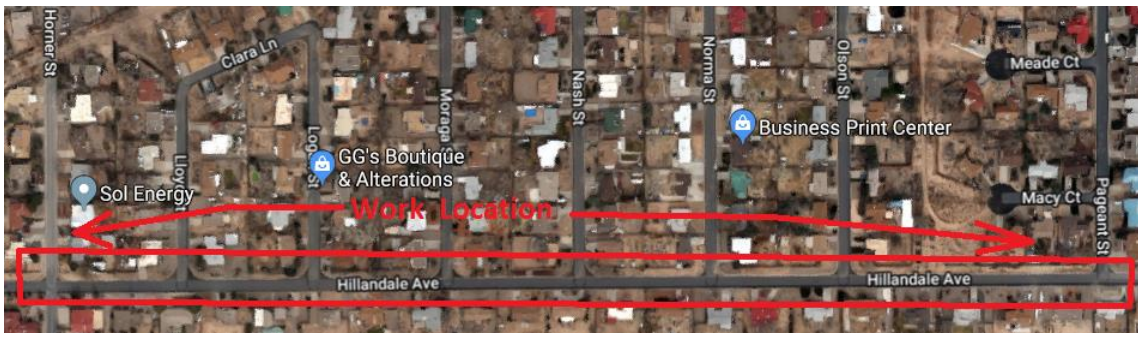
Repair #10

Surface Condition: Poor

Assessment: Complete breakdown of asphalt and base course

Repair: Repair pot hole/ chip and seal

Area: 79,634 SF (L2,746' X 29')

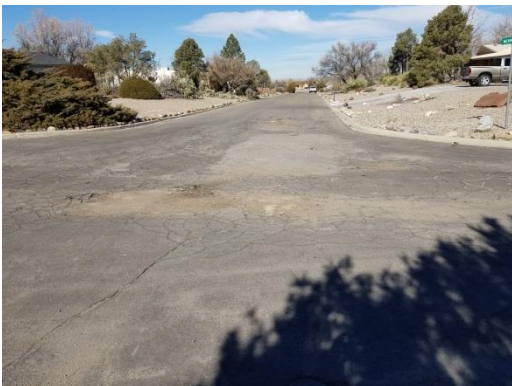
Repair #11

Surface Condition: Poor

Assessment: Complete breakdown of asphalt and base course

Repair: Full service repair (cut and replace)

Area: 1,508 SF (L52' X W29')

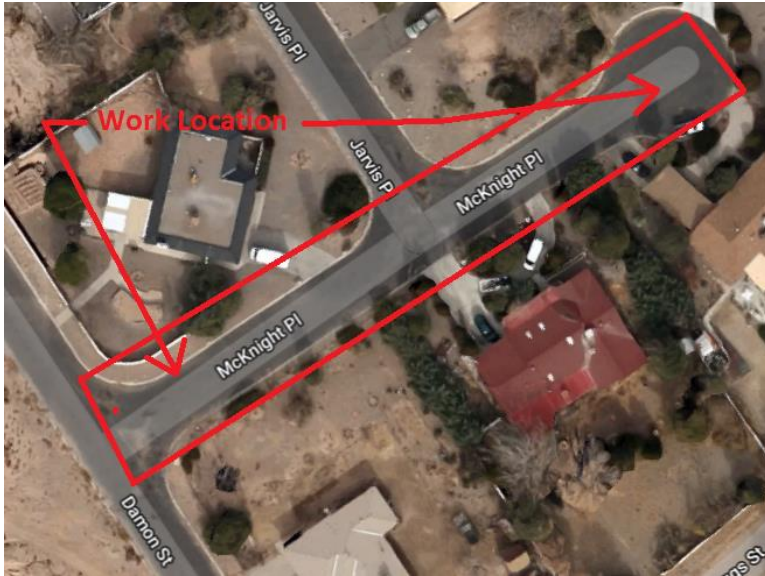
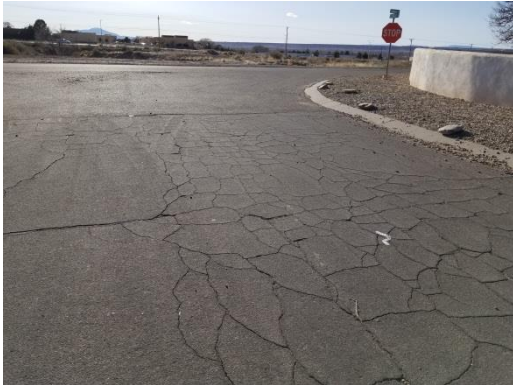
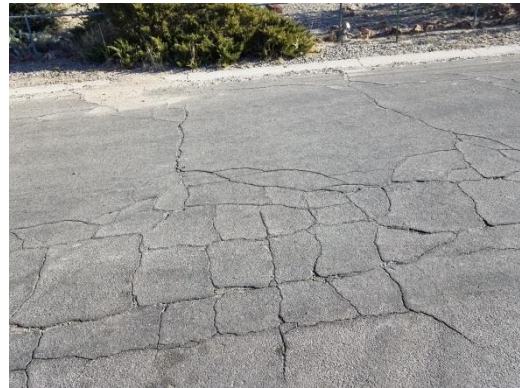
Repair #12

Surface Condition: Poor

Assessment: Complete breakdown of asphalt and base course

Repair: Combination full service repair (cut and replace and pot holes)

Area: 1,4100 SF (L470' X W30')
