City of Rio Communities,
Resolution 2017-82- A proposal to
participate in the NMDOT
Cooperative Agreement Program
for the expresses purpose of
repairing city roads and
intersections.

**2017-18 Road
Paving
Improvements**
City of Rio Communities,
New Mexico

Prepared by: Rio Communities
Planning and Zoning Commission

**City of Rio Communities
Index of Repair Site Locations**

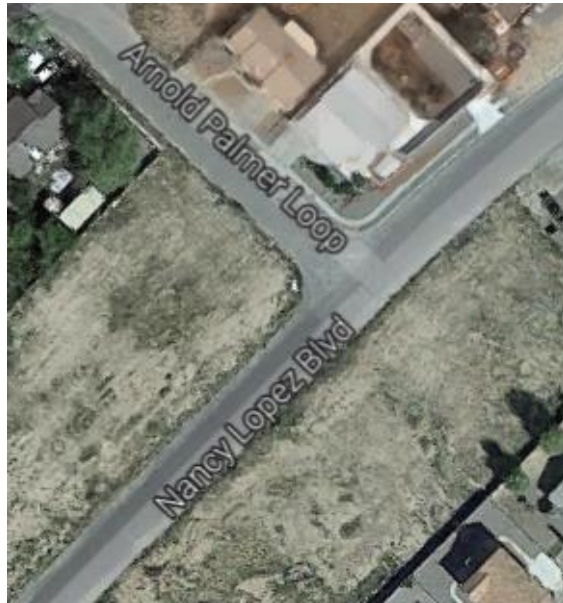
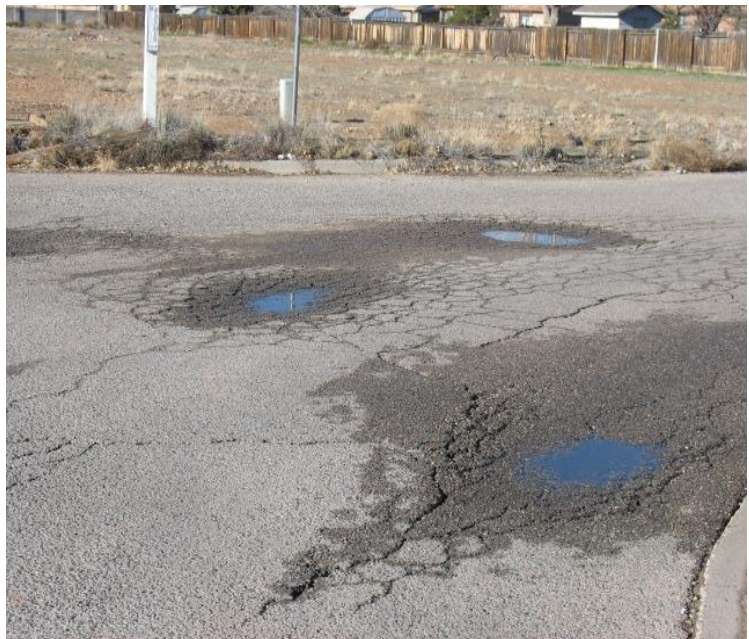
Repair #1
Intersection of
Arnold Palmer Lp and
Nancy Lopez Blvd

- Assessment:** Complete breakdown of asphalt and base course
- Repair:** Full service repair and replace
- Area:** 875 SF
- Scope of Work:** Mark and saw-cut area of repair; jackhammer and remove defective material; remove, replace with compacted base course; apply tack coat; place hot asphalt patch material in two 1.5-inch lifts, compacting after each applied lift; seal with joint sealant material.

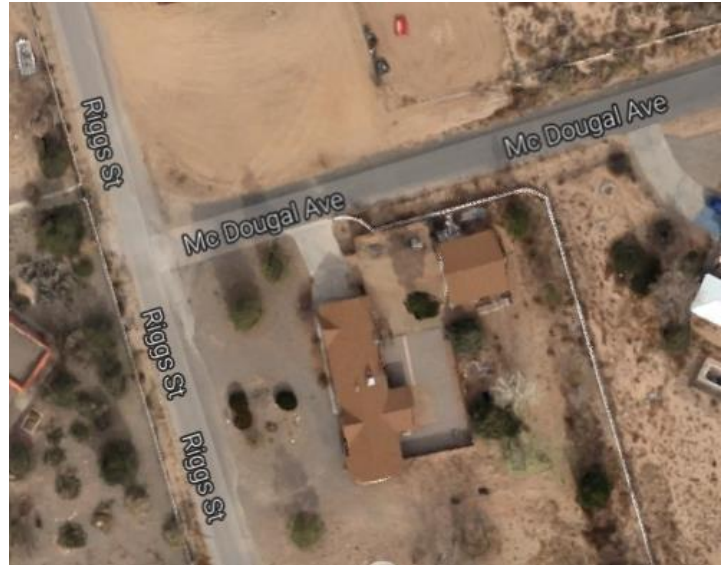
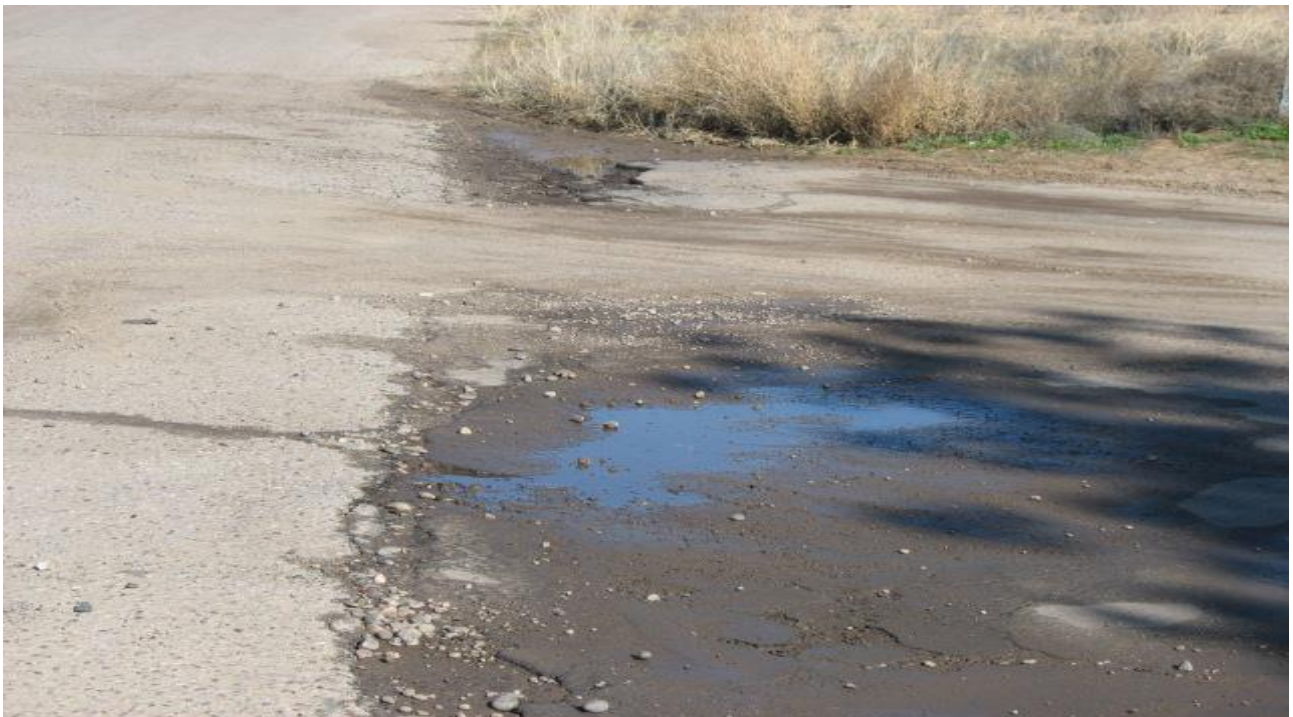
Repair #2
Intersection of
Riggs St and
McDougal Ave

- Assessment:** Complete breakdown of asphalt and base course
- Repair:** Full service repair and replace
- Area:** 1,040 SF
- Scope of Work:** Mark and saw-cut area of repair; jackhammer and remove defective material; remove, replace with compacted base course; apply tack coat; place hot asphalt patch material in two 1.5-inch lifts, compacting after each applied lift; seal with joint sealant material.

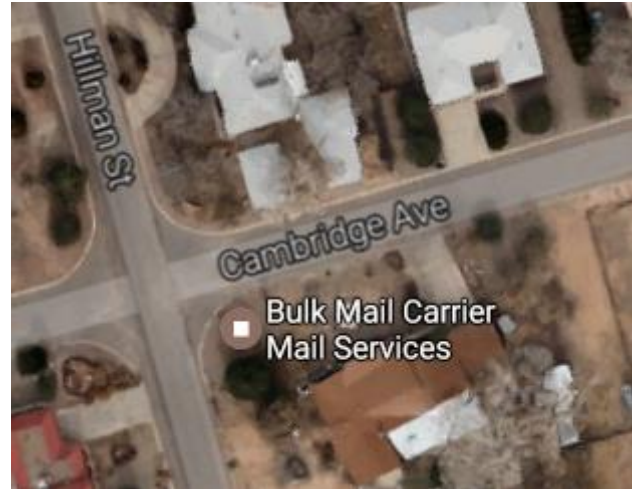
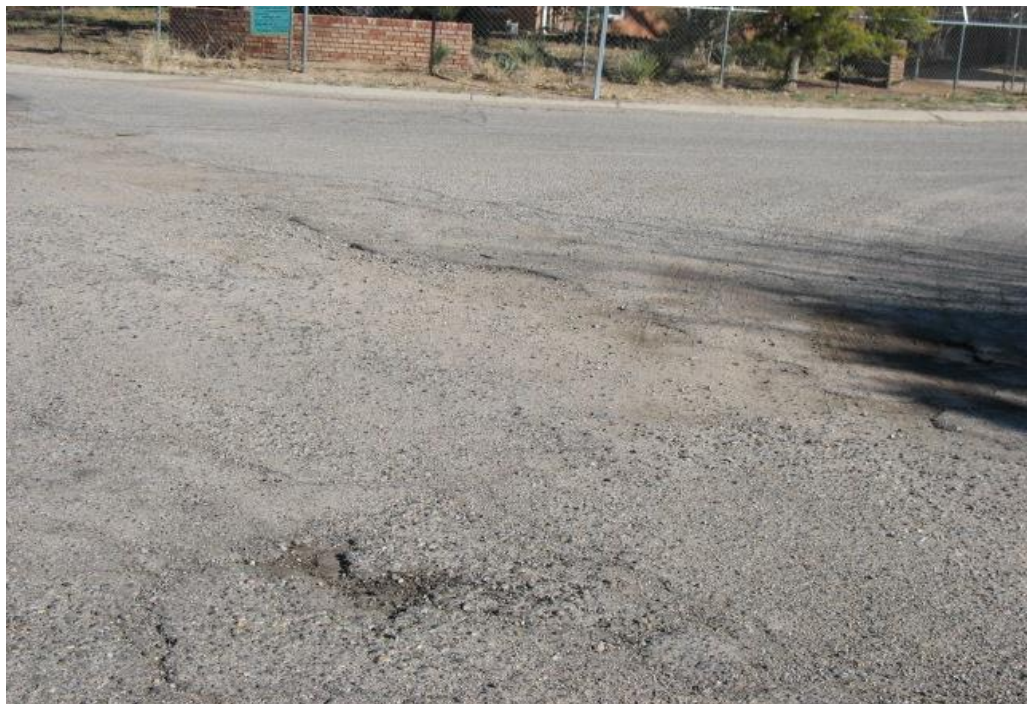
Repair #3
Intersection of
Cambridge Ave &
Hillman St (east)

- Assessment:** Complete breakdown of asphalt and base course
- Repair:** Full service repair and replace
- Area:** 2,625 SF
- Scope of Work:** Mark and saw-cut area of repair; jackhammer and remove defective material; remove, replace with compacted base course; apply tack coat; place hot asphalt patch material in two 1.5-inch lifts, compacting after each applied lift; seal with joint sealant material.

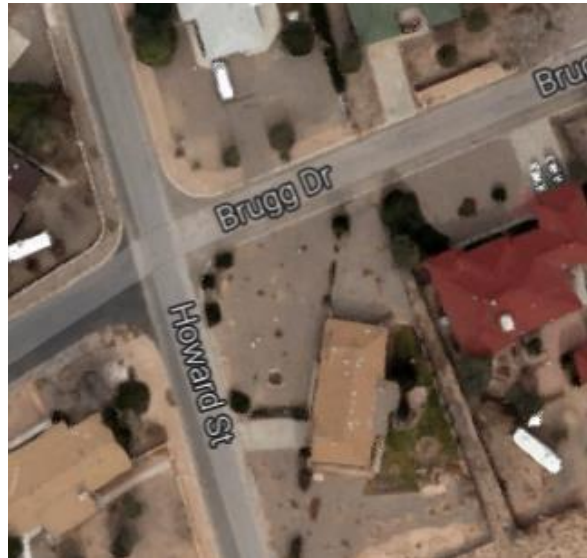
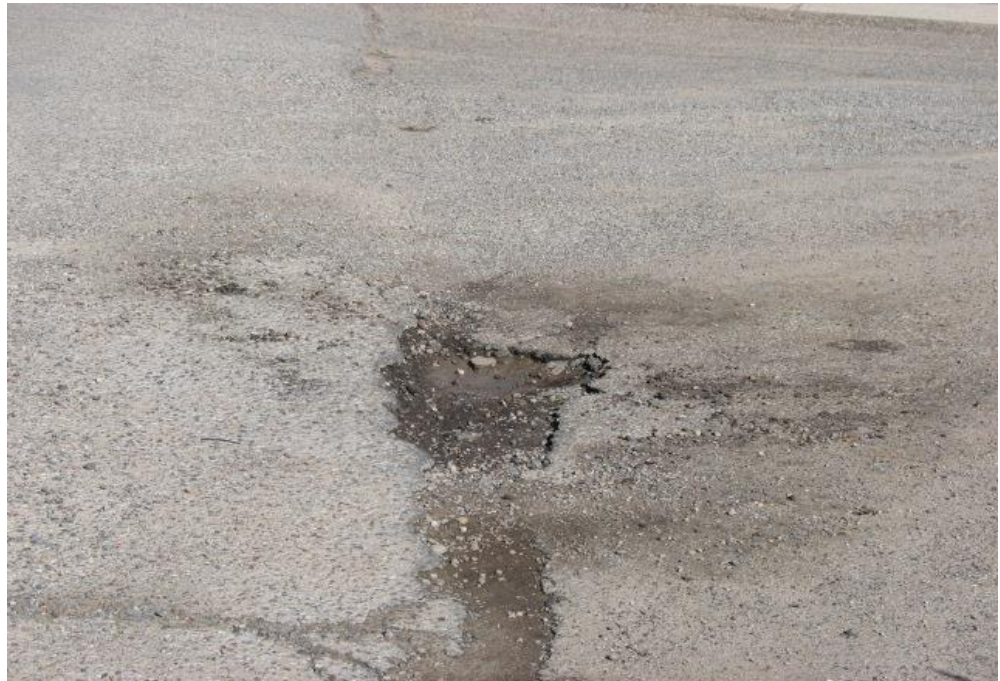
Repair #4
Intersection of
Brugg Dr Ave &
Howard St (east)

- Assessment:** Complete breakdown of asphalt and base course
- Repair:** Full service repair and replace
- Area:** 720 SF
- Scope of Work:** Mark and saw-cut area of repair; jackhammer and remove defective material; remove, replace with compacted base course; apply tack coat; place hot asphalt patch material in two 1.5-inch lifts, compacting after each applied lift; seal with joint sealant material.

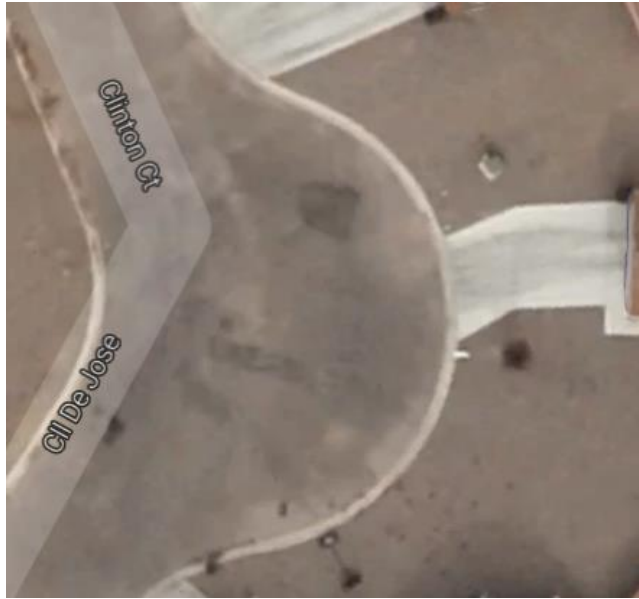
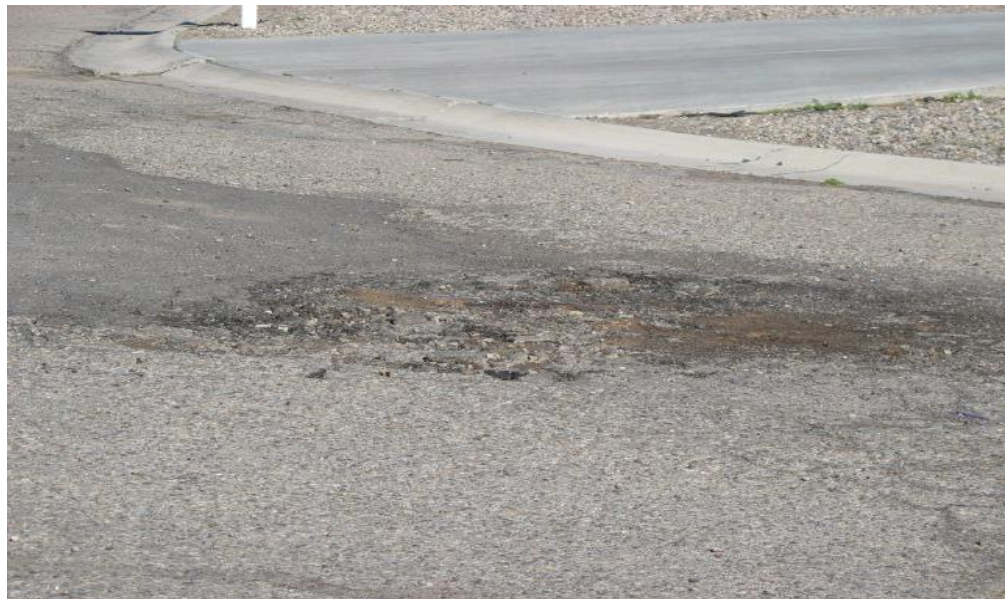
**Repair #5
Cul-de-Sac of
Clinton Ct**

- Assessment:** Complete breakdown of asphalt and base course
- Repair:** Full service repair and replace
- Area:** 1,440 SF
- Scope of Work:** Mark and saw-cut area of repair; jackhammer and remove defective material; remove, replace with compacted base course; apply tack coat; place hot asphalt patch material in two 1.5-inch lifts, compacting after each applied lift; seal with joint sealant material.

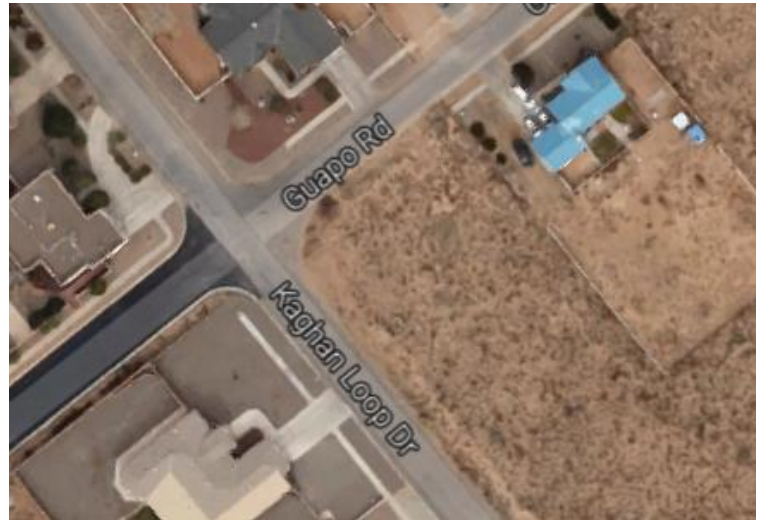
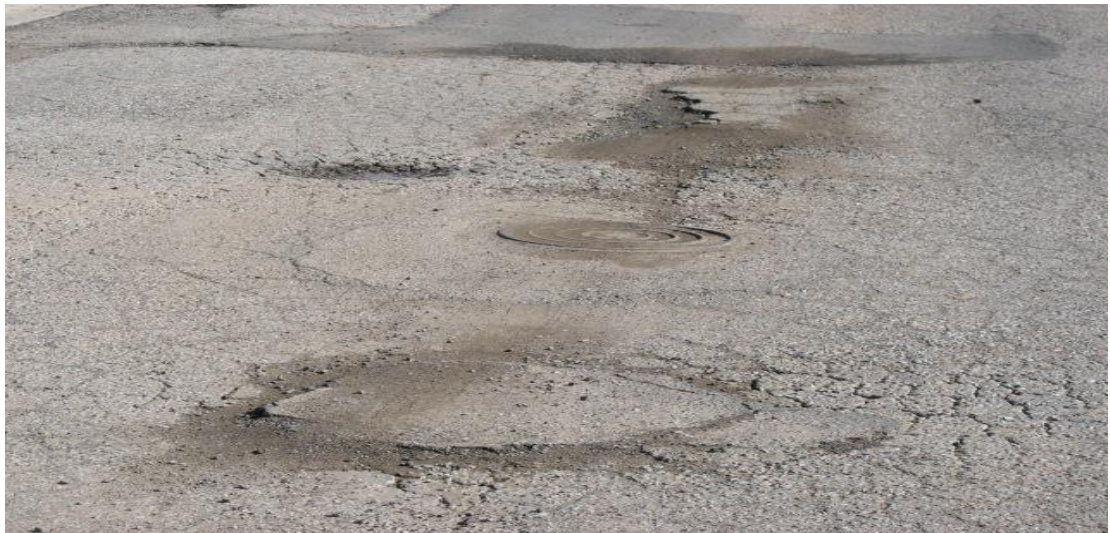
Repair #6
Intersection of
Guapo Rd &
Kaghan Lp (east)

- Assessment:** Complete breakdown of asphalt and base course
- Repair:** Full service repair and replace
- Area:** 5,343 SF
- Scope of Work:** Mark and saw-cut area of repair; jackhammer and remove defective material; remove, replace with compacted base course; apply tack coat; place hot asphalt patch material in two 1.5-inch lifts, compacting after each applied lift; seal with joint sealant material.

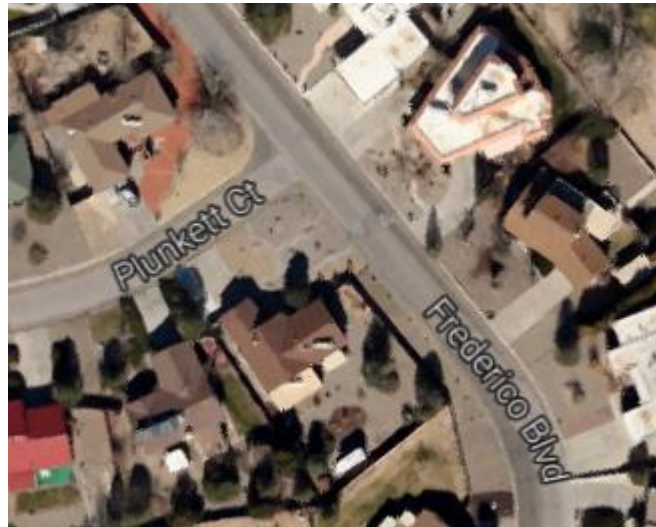
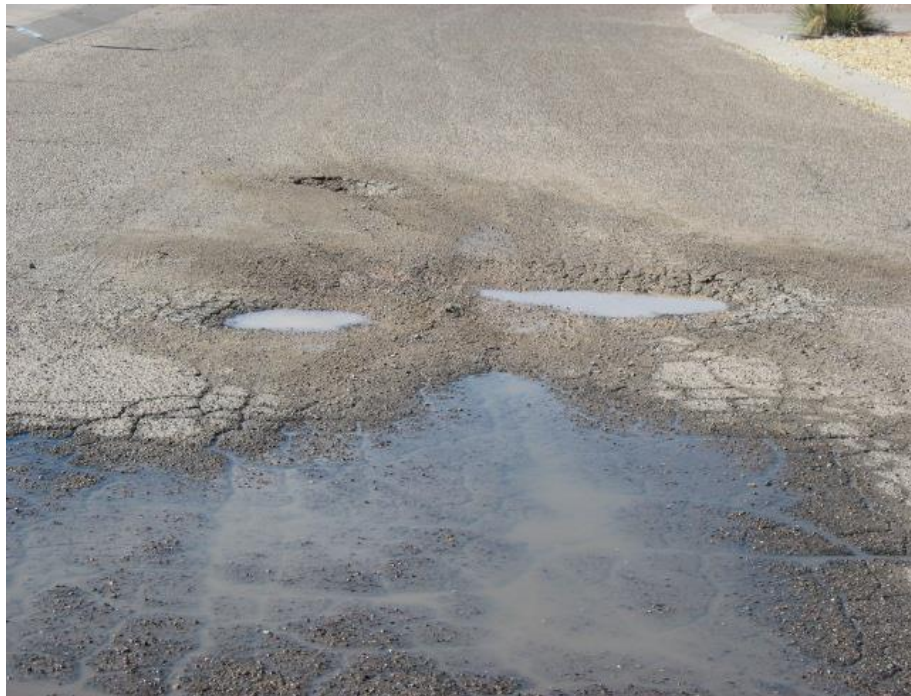
**Repair #7
Frederico Blvd &
Plunkett Ct.**

- Assessment:** Complete breakdown of asphalt and base course
- Repair:** Full service repair and replace
- Area:** 1,000 SF
- Scope of Work:** Mark and saw-cut area of repair; jackhammer and remove defective material; remove, replace with compacted base course; apply tack coat; place hot asphalt patch material in two 1.5-inch lifts, compacting after each applied lift; seal with joint sealant material.

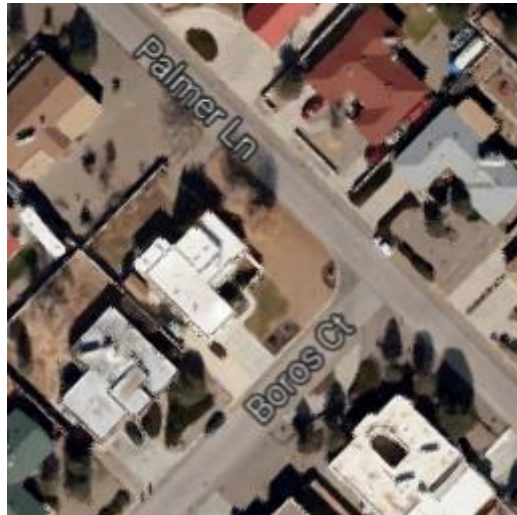
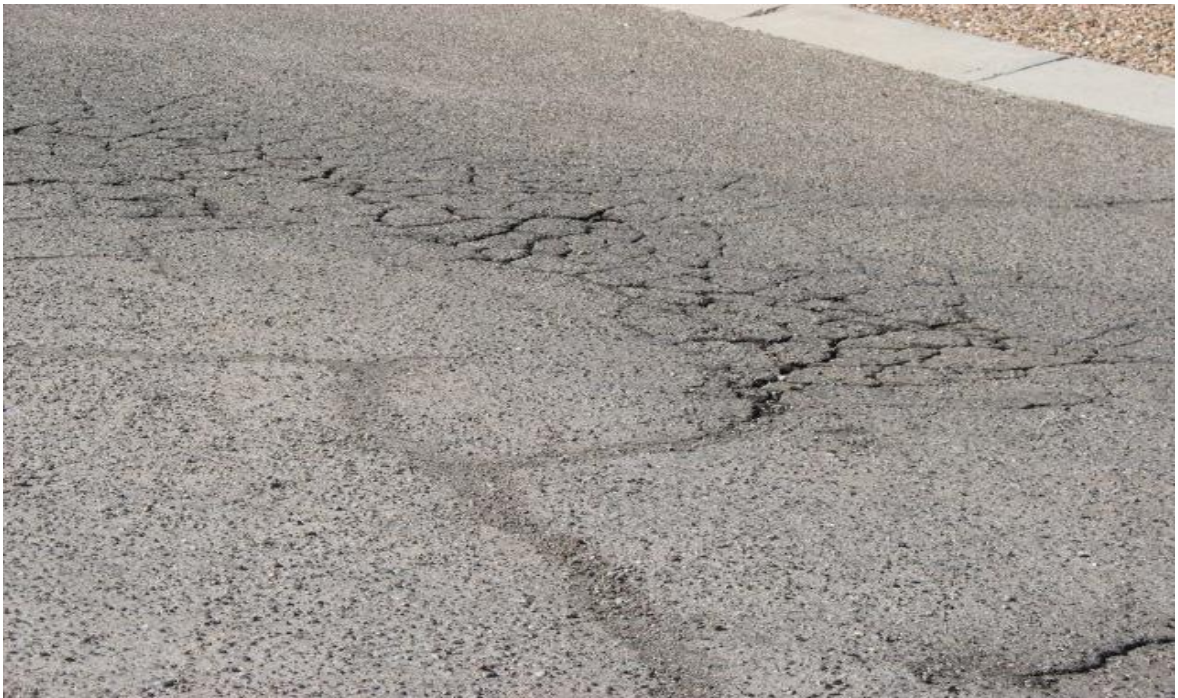
**Repair #8
Palmer Ln &
Boros Ct.**

- Assessment:** Complete breakdown of asphalt and base course
- Repair:** Full service repair and replace
- Area:** 1,024 SF
- Scope of Work:** Mark and saw-cut area of repair; jackhammer and remove defective material; remove, replace with compacted base course; apply tack coat; place hot asphalt patch material in two 1.5-inch lifts, compacting after each applied lift; seal with joint sealant material.

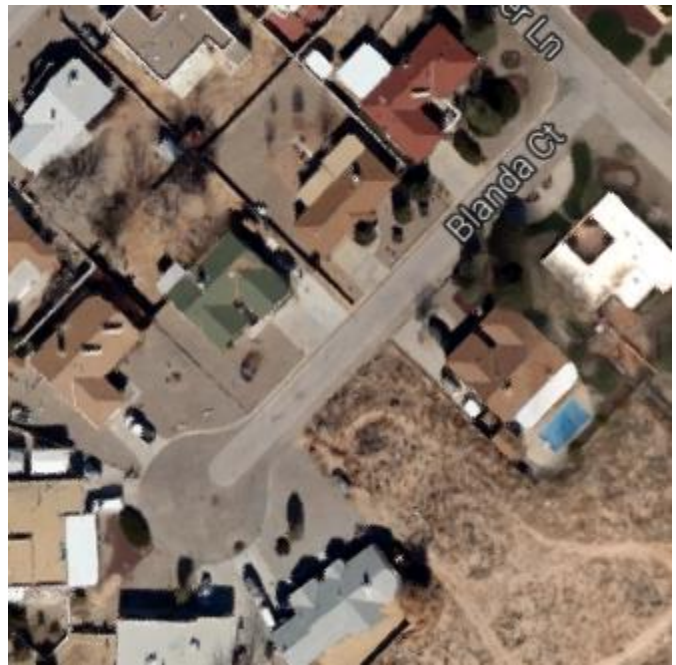
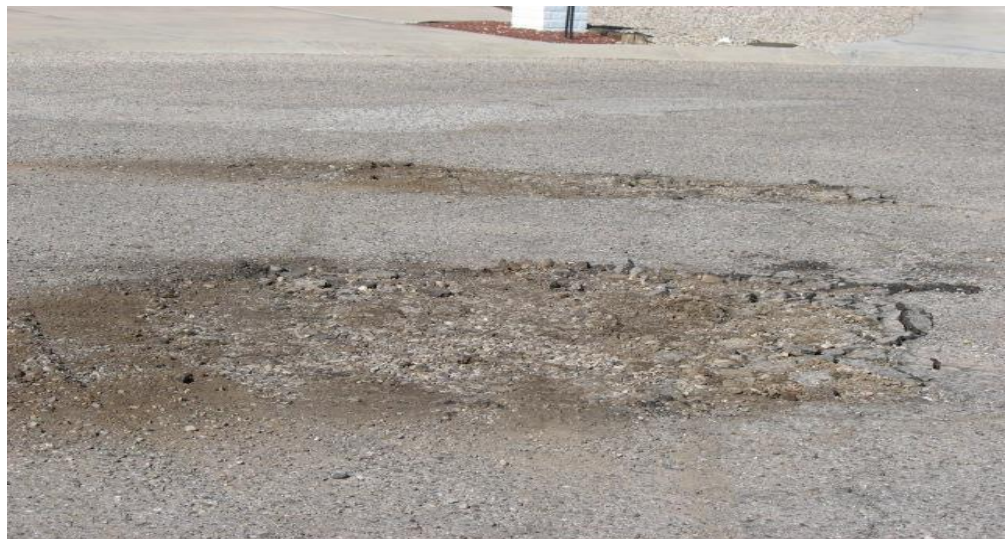
Repair #9
Blanda Ct (turn-around)

- Assessment:** Complete breakdown of asphalt and base course
- Repair:** Full service repair and replace
- Area:** 1,326 SF
- Scope of Work:** Mark and saw-cut area of repair; jackhammer and remove defective material; remove, replace with compacted base course; apply tack coat; place hot asphalt patch material in two 1.5-inch lifts, compacting after each applied lift; seal with joint sealant material.

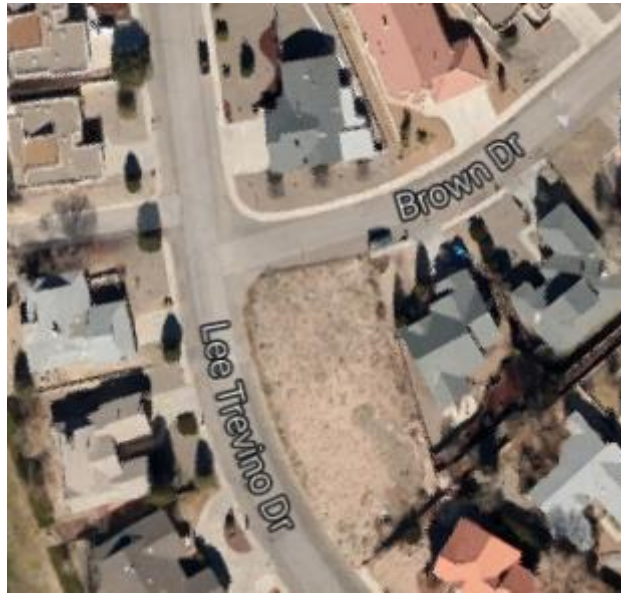
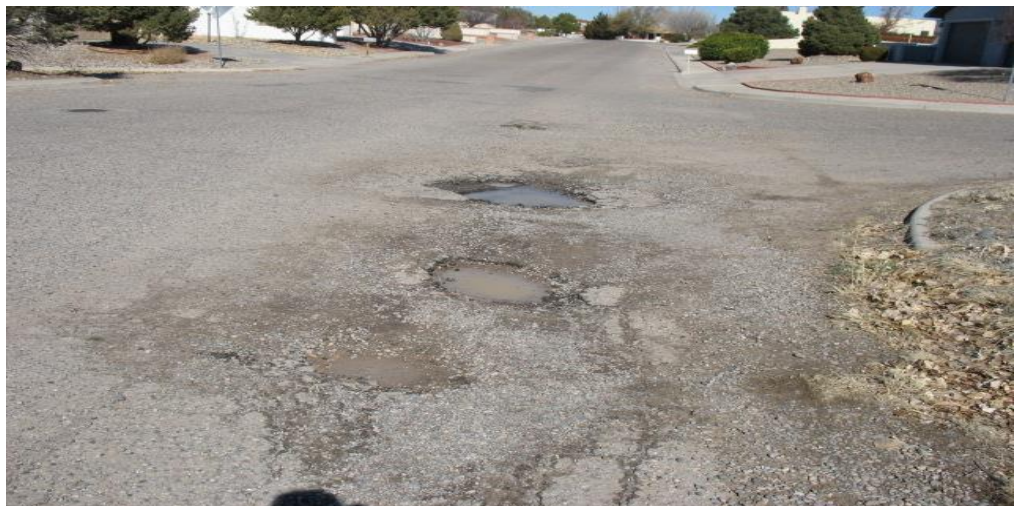
Repair #10
Intersection of
Lee Trevino Blvd &
Brown Rd

- Assessment:** Complete breakdown of asphalt and base course
- Repair:** Full service repair and replace
- Area:** 1,584 SF
- Scope of Work:** Mark and saw-cut area of repair; jackhammer and remove defective material; remove, replace with compacted base course; apply tack coat; place hot asphalt patch material in two 1.5-inch lifts, compacting after each applied lift; seal with joint sealant material.

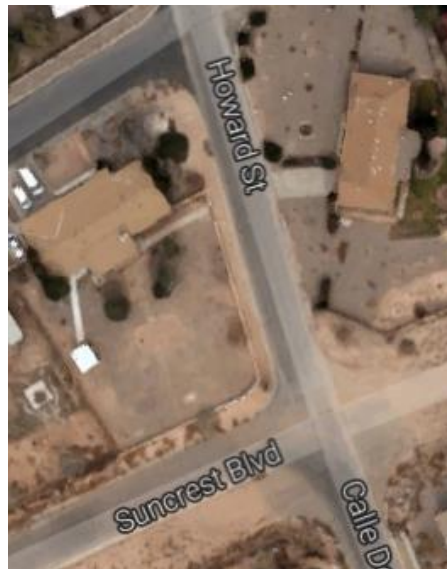
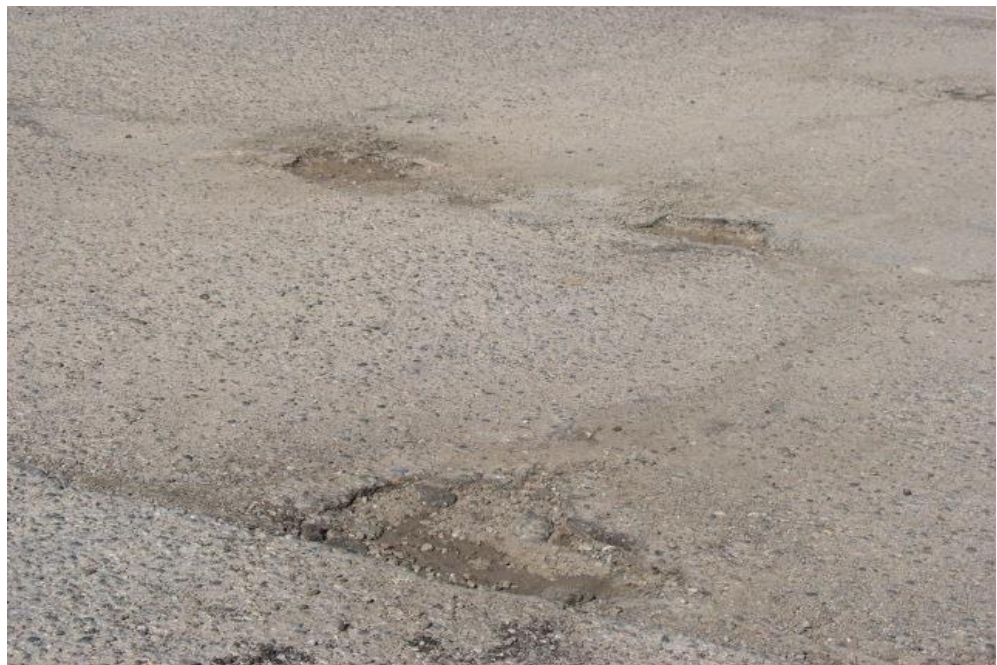
Repair #11
Intersection of
Suncrest Blvd &
Howard St

- Assessment:** Complete breakdown of asphalt and base course
- Repair:** Full service repair and replace
- Area:** 1,560 SF
- Scope of Work:** Mark and saw-cut area of repair; jackhammer and remove defective material; remove, replace with compacted base course; apply tack coat; place hot asphalt patch material in two 1.5-inch lifts, compacting after each applied lift; seal with joint sealant material.

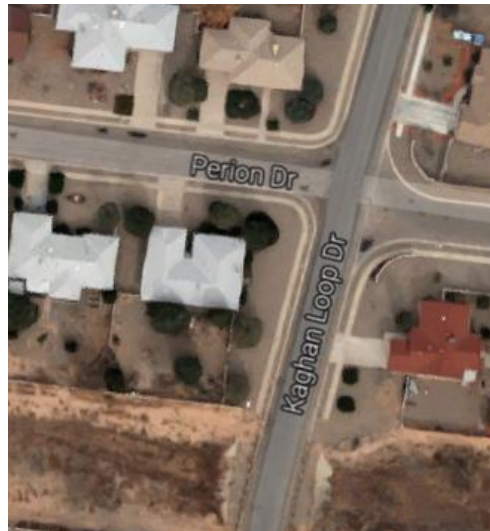
**Repairs #12 & #13
Intersection of
Kaghan Lp &
Perion Ct**

- Assessment:** Complete breakdown of asphalt and base course
Repair: Full service repair and replace
Area: 2,982 & 875 SF
Scope of Work: Mark and saw-cut area of repair; jackhammer and remove defective material; remove, replace with compacted base course; apply tack coat; place hot asphalt patch material in two 1.5-inch lifts, compacting after each applied lift; seal with joint sealant material.

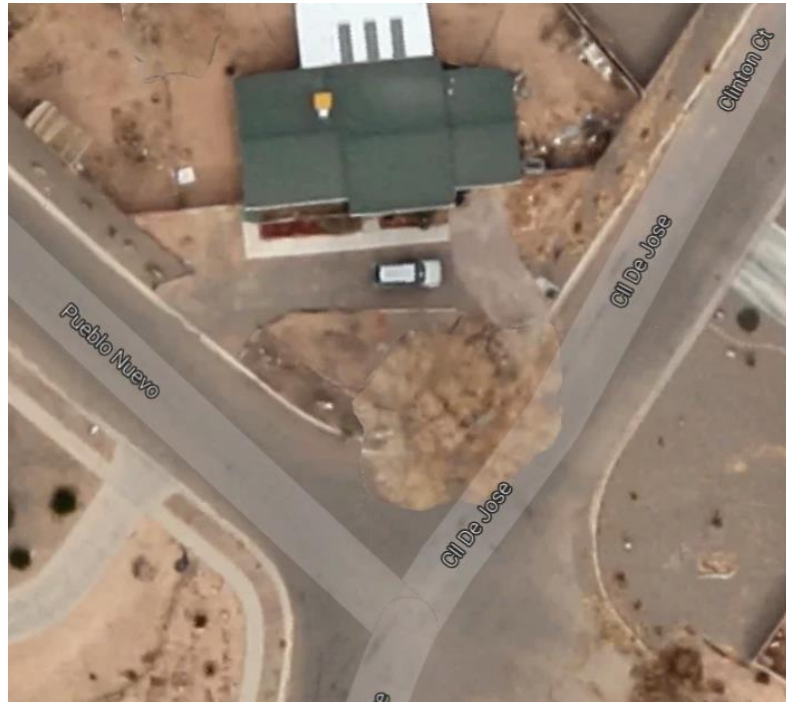
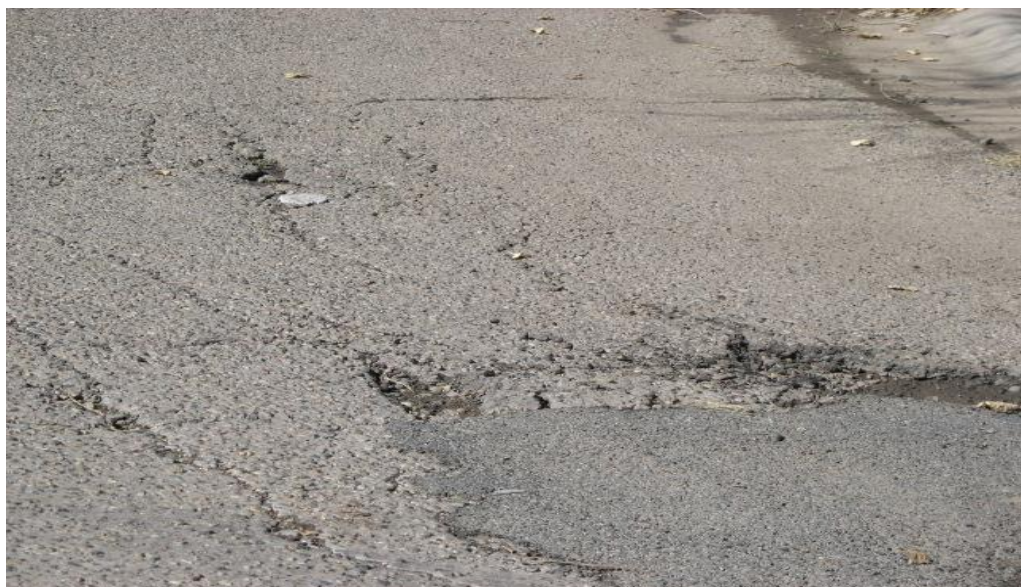
**Repair #14
Intersection of
Clinton Ct &
Pueblo Nuevo**

Complete breakdown of asphalt and base course

700 SF

Full service repair and replace

Mark and saw-cut area of repair; jackhammer and remove defective material; remove, replace with compacted base course; apply tack coat; place hot asphalt patch material in two 1.5-inch lifts, compacting after each applied lift; seal with joint sealant material.

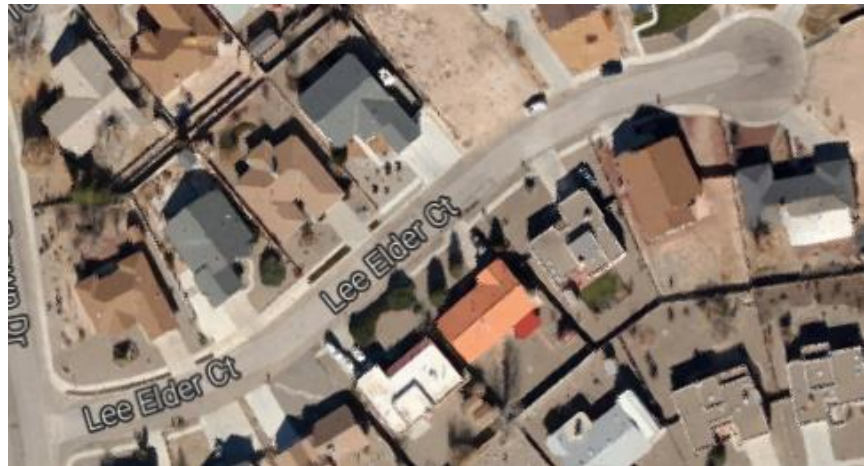
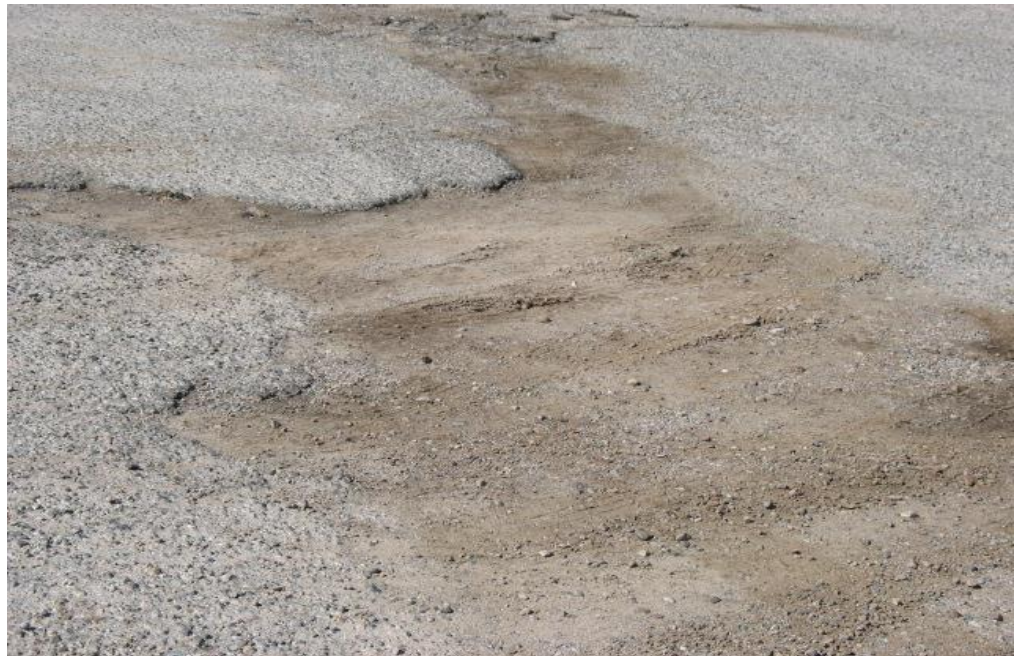
**Repair #15
Cul-de-Sac of
Lee Elder Ct**

- Assessment:** Complete breakdown of asphalt and base course
- Repair:** Full service repair and replace
- Area:** 1,050 SF
- Scope of Work:** Mark and saw-cut area of repair; jackhammer and remove defective material; remove, replace with compacted base course; apply tack coat; place hot asphalt patch material in two 1.5-inch lifts, compacting after each applied lift; seal with joint sealant material.

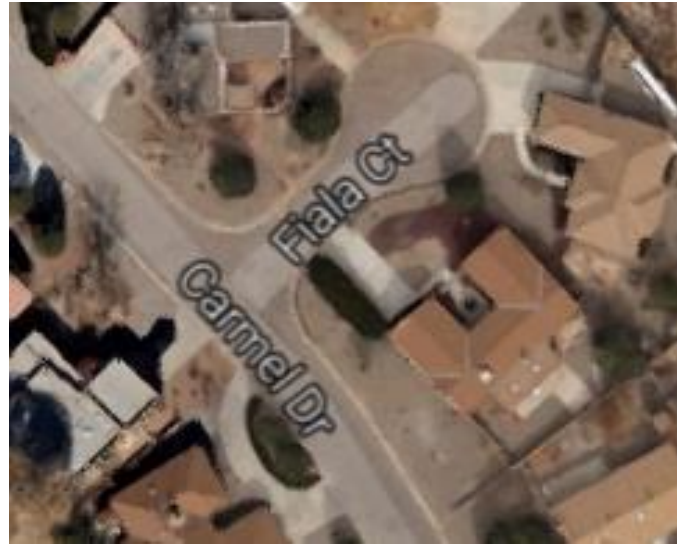
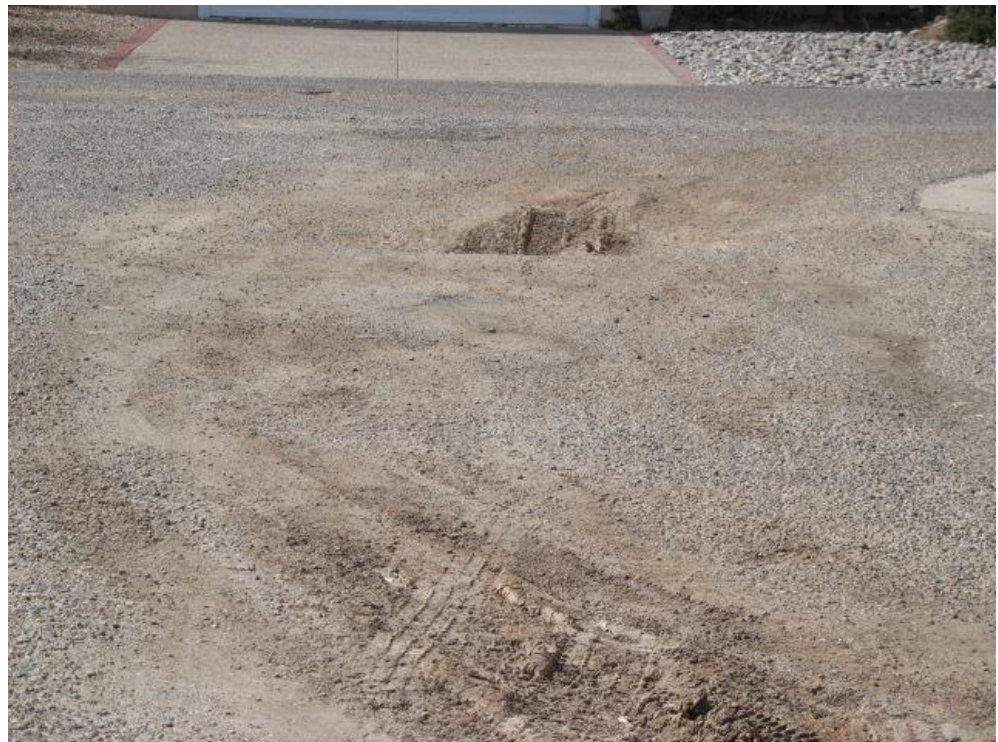
Repair #16
Fiala Ct (entire street)

- Assessment:** Complete breakdown of asphalt and base course
- Repair:** Full service repair and replace
- Area:** 4,144 SF
- Scope of Work:** Mark and saw-cut area of repair; jackhammer and remove defective material; remove, replace with compacted base course; apply tack coat; place hot asphalt patch material in two 1.5-inch lifts, compacting after each applied lift; seal with joint sealant material.

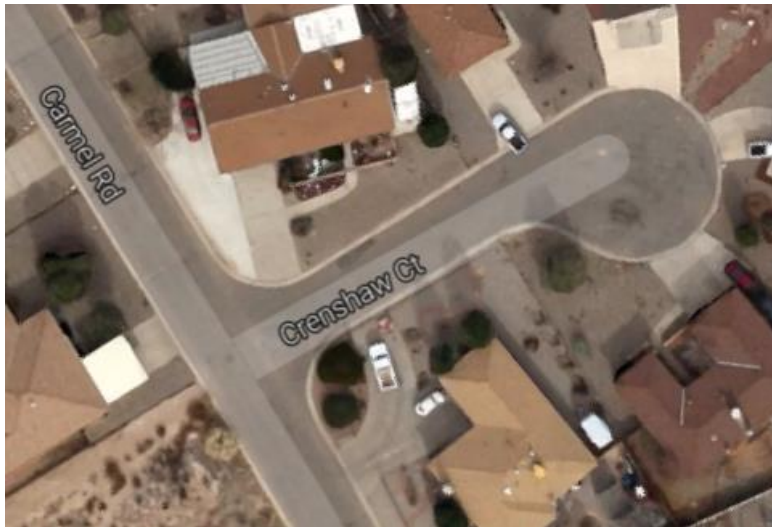
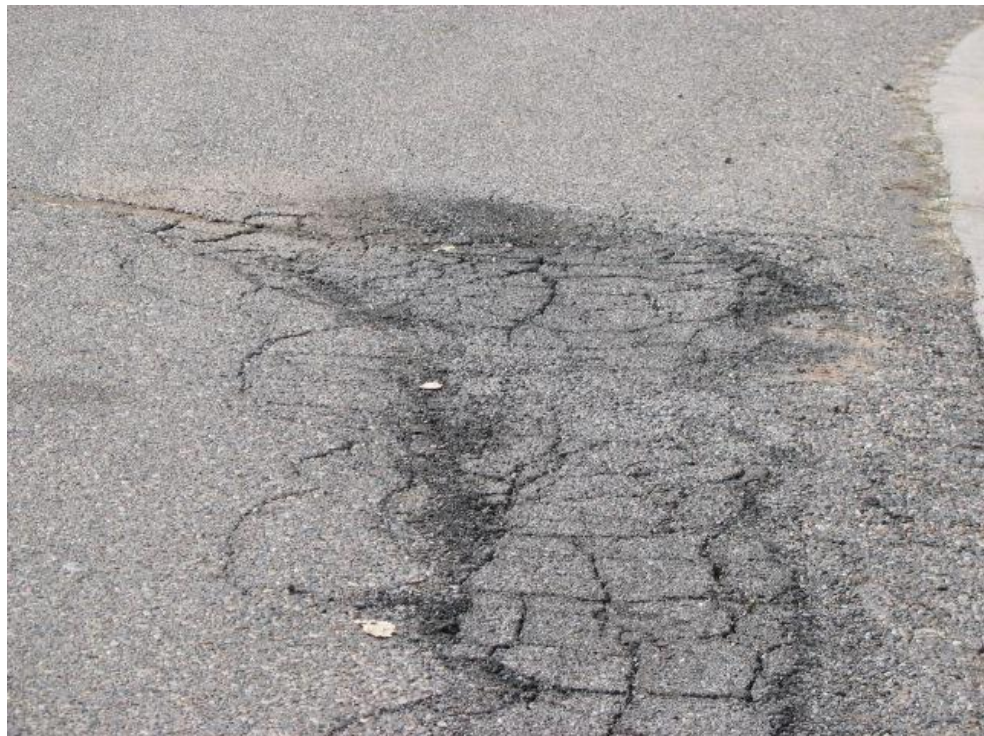
**Repair #17
Crenshaw Ct
(entire street)**

- Assessment:** Complete breakdown of asphalt and base course
Repair: Full service repair and replace
Area: 5,320 SF
Scope of Work: Mark and saw-cut area of repair; jackhammer and remove defective material; remove, replace with compacted base course; apply tack coat; place hot asphalt patch material in two 1.5-inch lifts, compacting after each applied lift; seal with joint sealant material.

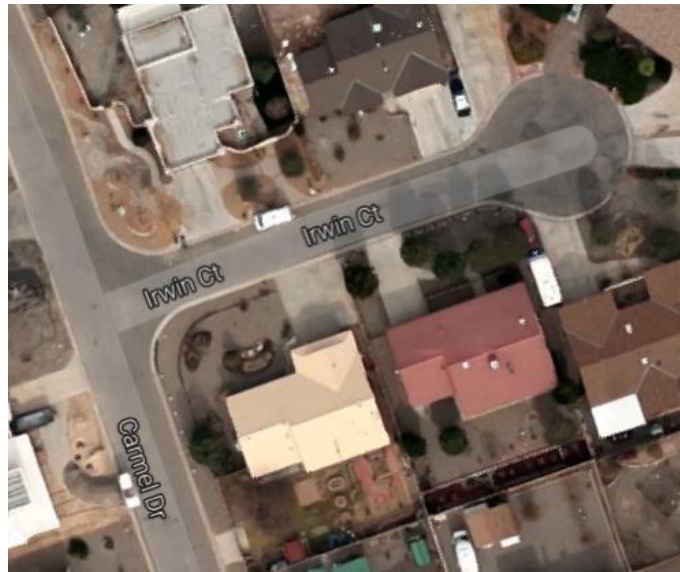
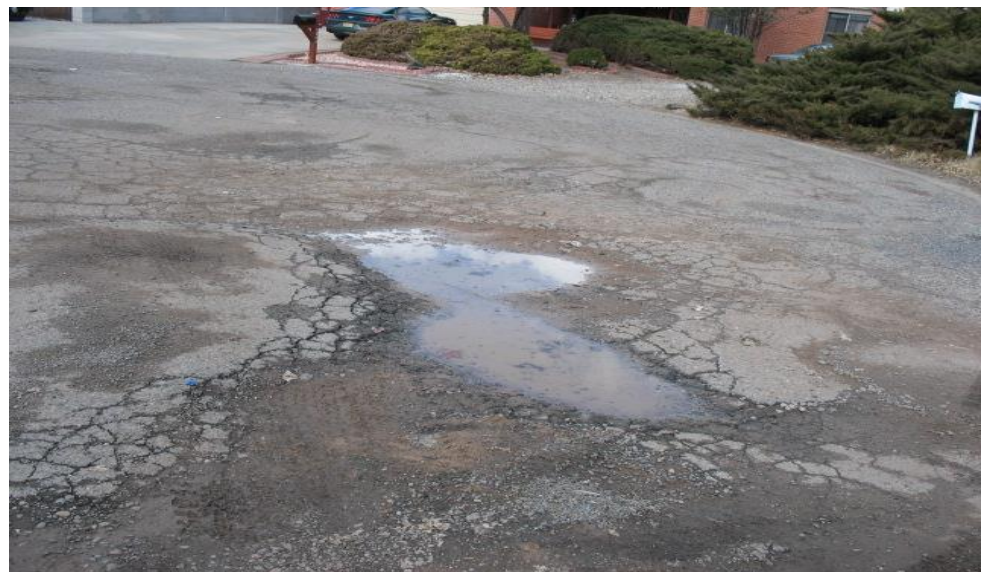
**Repair #18
Irwin Ct
(entire street)**

- Assessment:** Complete breakdown of asphalt and base course
- Repair:** Full service repair and replace
- Area:** 6,664 SF
- Scope of Work:** Mark and saw-cut area of repair; jackhammer and remove defective material; remove, replace with compacted base course; apply tack coat; place hot asphalt patch material in two 1.5-inch lifts, compacting after each applied lift; seal with joint sealant material.

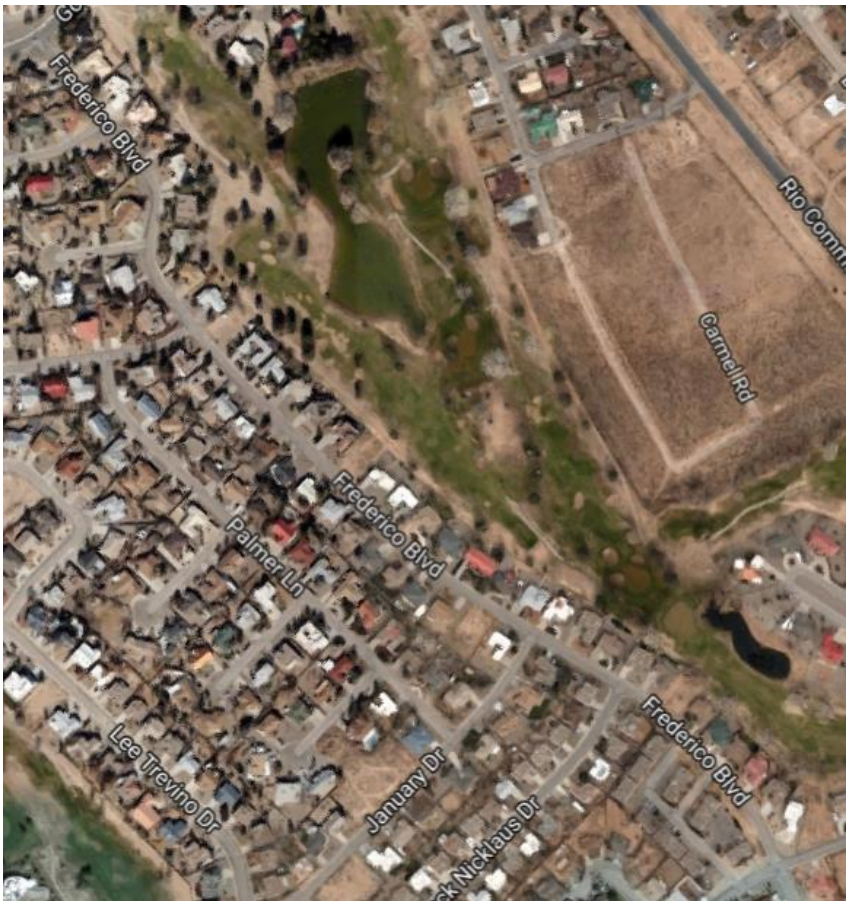
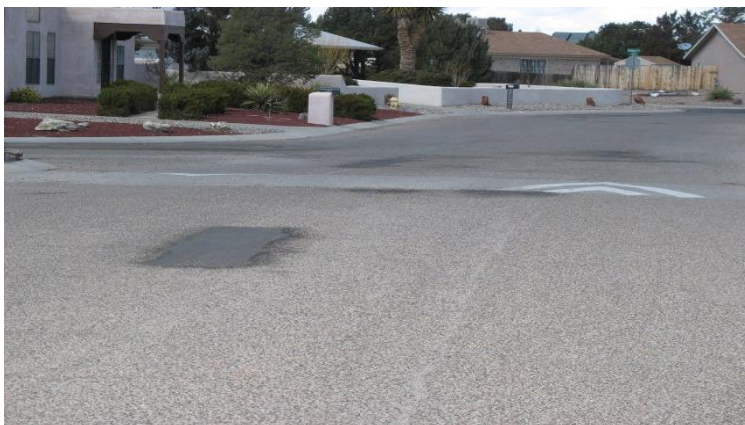
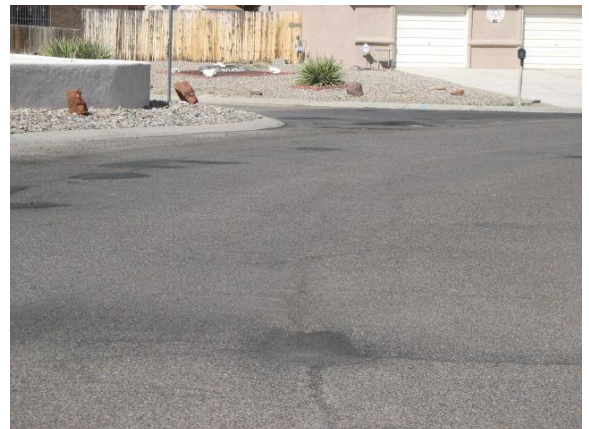
**Repair #19
Frederico Blvd
(entire street)**

- Assessment:** Chip and seal needed
- Repair:** Full service chip and seal with fog seal
- Area:** 114,880 SF
- Scope of Work:** Contractor shall perform all work in accordance with the most current editions of New Mexico Department of Transportation (NMDOT) publications and specifications concerning the application of a chip and seal and fog seal repair.
